Sweden Case Study

Deep Foamjection™

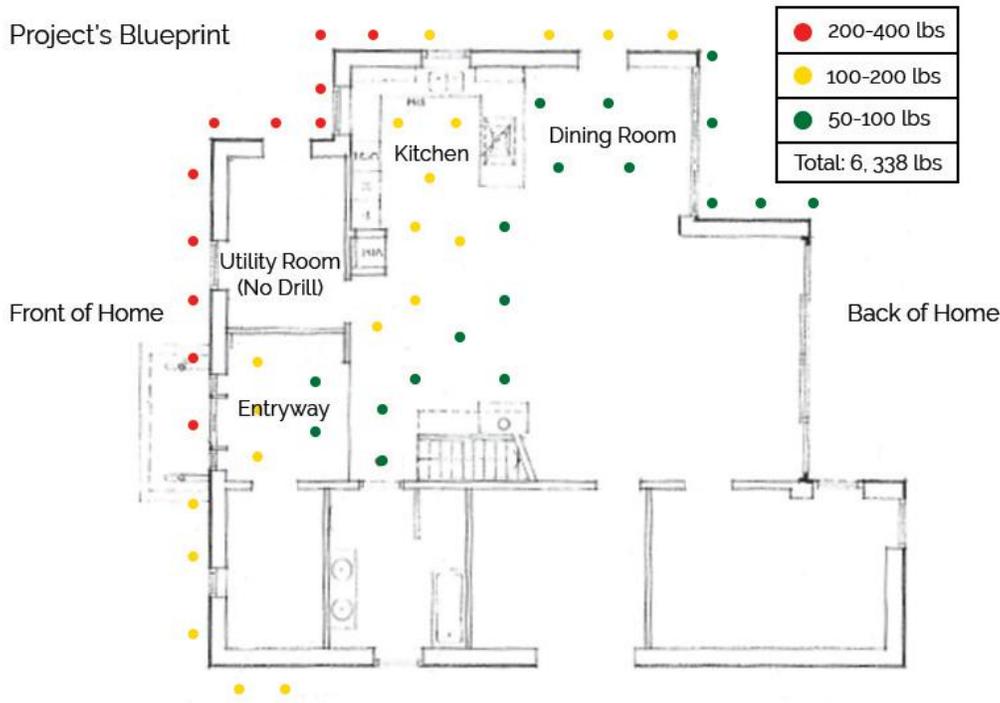
This map identifies that areas where material was injected to stabilize and lift the slab. The areas in red received the most foam where the slab was raised up to 3 ½ inches. The yellow and green areas supported the lift and stabilized the slab.
