# Case Study

## DuBois Machine Company Void Fill

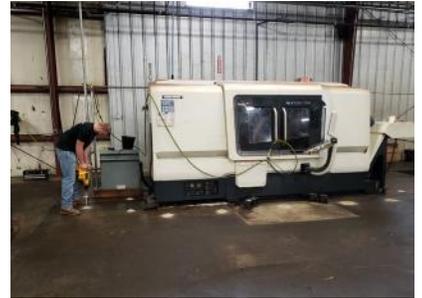
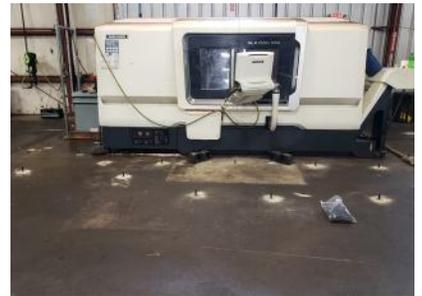
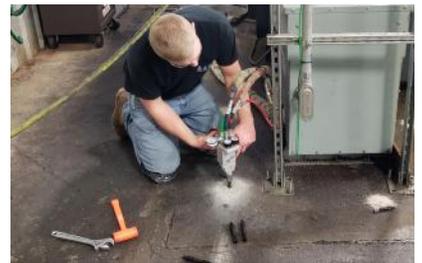
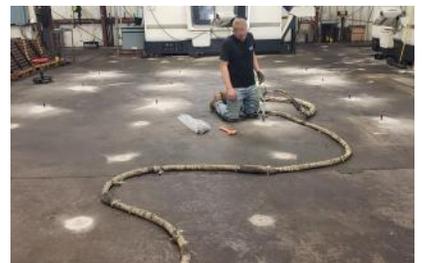
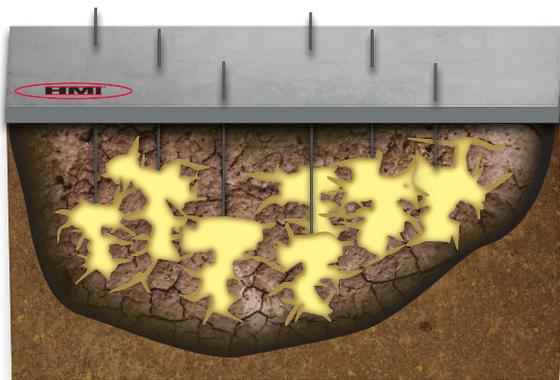
A one inch void was found under the slab due to erosion; The shop was built on marshland. This allowed for no support causing the slab to deflect significantly.

The local concrete lifting company was called and the work was completed in 6 hours. Using the EliteOne gun and HMI's 501 polyurethane foam the void was filled, which stabilized the concrete slab. 501 polyurethane foam was chosen for this job because it provides a slower reaction time and further spread. Due to the distance this foam can travel, 501 is excellent for undersealing and stabilizing joints on rocking slabs from slab curl. The same dial gauge test was performed after the foam was injected, and showed no deflection. The CNC's were re-leveled and operations continued. The only alternative would have been to tear out, and replace the entire slab. Which would have affected production greatly. By choosing to fill the void, they were able to continue production immediately following the repair.

853 lbs of HMI 501 stabilizing polyurethane foam
