# Case Study

## Kewaunee Seawall Repair

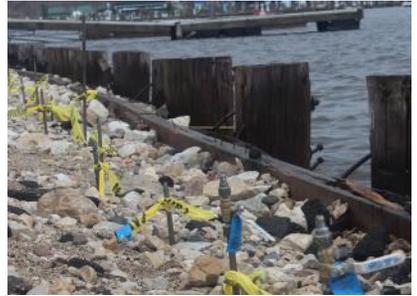
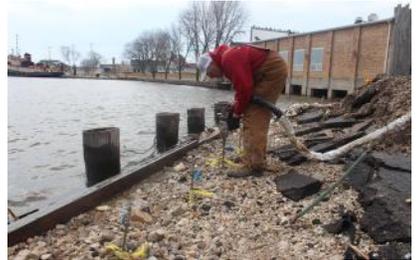
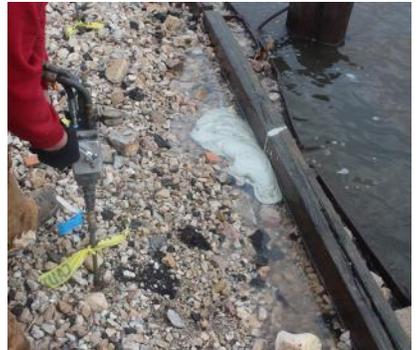
RaiseRite Concrete Lifting (HMI's Contracting Division) was contacted by a local contractor who was looking for options to repair a failing seawall for a small business along the Lake Michigan shoreline. The issue was that the steel corrugated barrier was deteriorating and soil was washing out underneath the barrier and through holes within the seawall causing the parking lot of this business to settle.

RaiseRite Concrete Lifting used the Deep Foamjection™ process to stabilize the soil to support the barrier and prevent further erosion and loss of soils. Deep Foamjection™ is the process of injecting foam to specified depths to increase the load bearing capacity of the soils. The foam used for this project was crucial because a truly hydro-insensitive foam was needed. HMI Hydrofoam was specifically designed for jobs where water or moisture is present. This 4 lb. per cubic foot foam was designed to set up in the presence of water and to maintain dimensional stability in wet environments. (As shown in the picture to the right- no chemicals are leaching into the water, and the foam is setting up perfectly). The project was completed in 4 days and 4,175 lbs. of HMI 402 HydroFoam was injected. The customer could then immediately continue repairs to the parking lot.

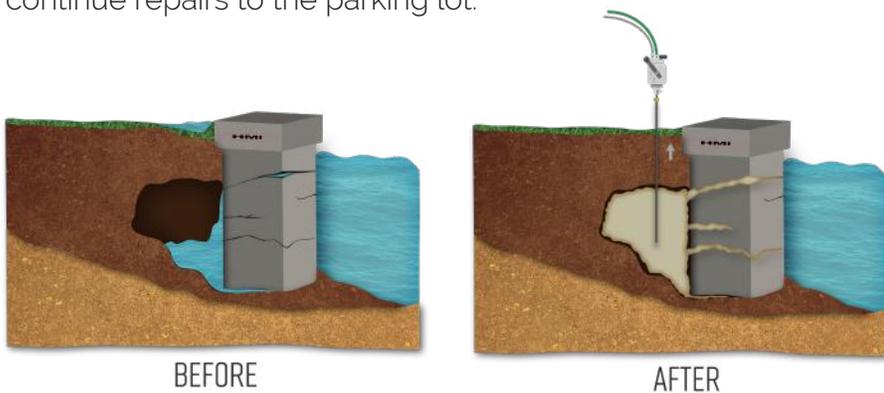
Foam setting up in water.  
No Chemicals leaching into the water.
