# Case Study-Grain Bin

## Deep Foamjection Stabilization and Raising Project

Unstable soils underneath a settled grain bin located in Cedar, Kansas.

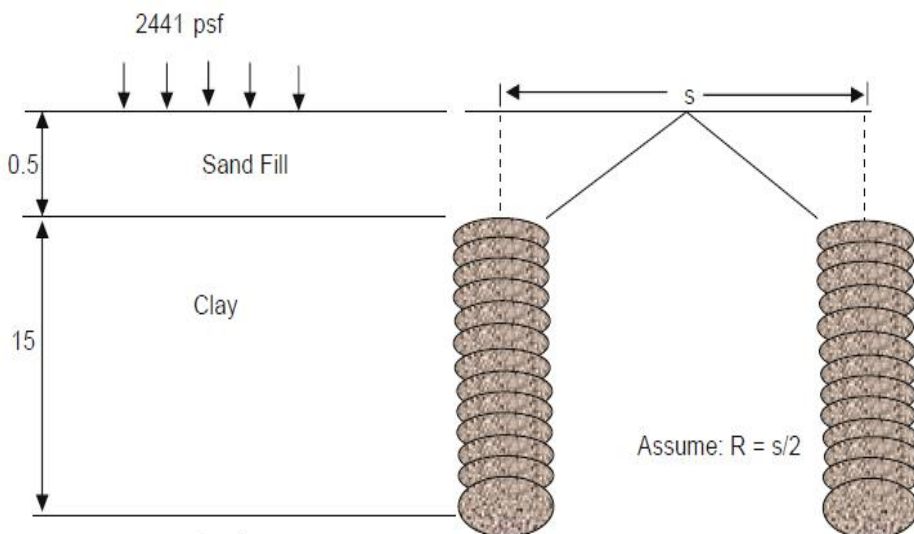
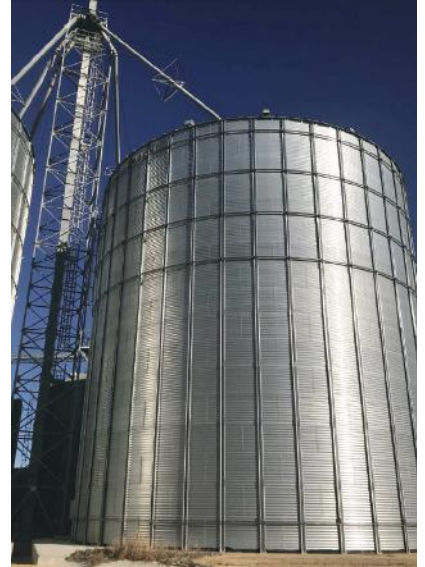
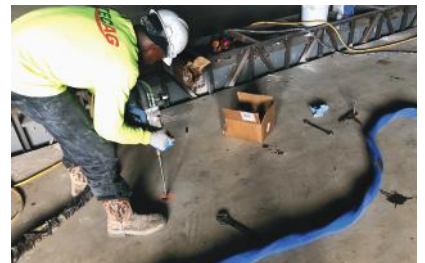
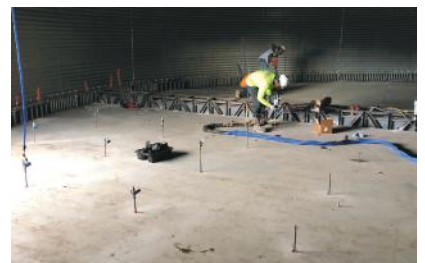
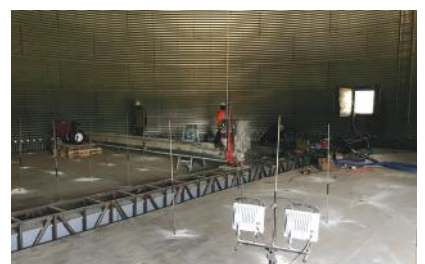
Located in Cedar, Kansas, this 150,000 bushel capacity grain bin was constructed in 2010 over a Geopier-reinforced subgrade. The slab was constructed with a ring footing foundation on a 6" thick floor over a 6" base of granular fill. At full capacity, the grain load for this bin is 2,441 psf with a total weight of 4,600 tons which the combination of subgrade and geopiers we unable to support.

Previously installed geopiers had been installed at a depth of 15 feet. In conjunction with the weak subgrade, there was not enough strength to support the full weight of the filled grain bin, Half of the slab settled by 6 inches.

The full repair would require to first stabilize the subgrade, then attempt to lift the settled slab up to 6 inches. Alternative repair methods were bid exceeding \$1M with months of demolition and construction. With fall harvest approaching this repair was time sensitive.

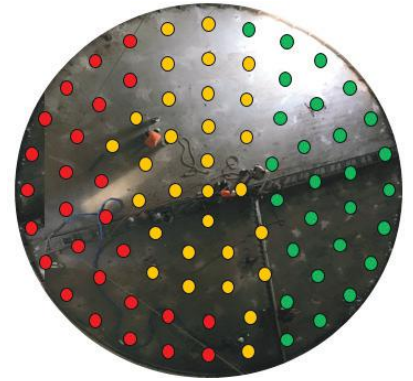
A four foot grid pattern of 106 points were used to install Hydrofoam 402 at a depth of 12-15 feet to stabilize the soil. Each injection point accepted 15-75 pounds of material as noted in the color-coded chart below. Using an HMI EliteONE injection gun, a total amount of 4,500 pounds of HF402 foam was incrementally installed into the soil to stabilize the subgrade. HF402 was chosen for stabilization due to the potential water present, strength and the ideal reaction profile for Deep Foamjection.

| ● 60-75 LBS |
| ● 35-55 LBS |
| ● 15-30 LBS |
