# Case Study

## Gymnasium Repair

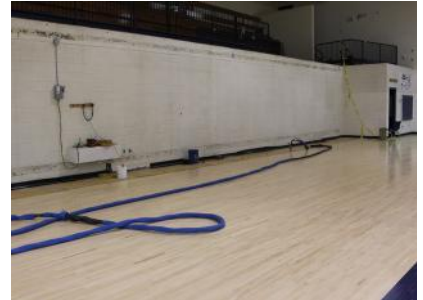
**Before**

The Sault Area High School in Sault Ste. Marie, Michigan was refinishing their gymnasium floor and installing new bleachers. Upon removal of the old bleachers it was discovered that the gymnasium floor had settled along the west wall. RaiseRite Concrete Lifting (HMI's Contracting Division) was referred to by an outside engineering firm to repair the sunken floor. An appointment for inspection of the area was made and it was determined that ninety feet of the floor had settled one and a half inches. Because the wood floor could not be removed it was decided that HMI 401 high density polyurethane foam would be used to lift the concrete. An estimate for the repair was written the next day and later approved by the high school. A few weeks later a RaiseRite crew was on-site ready to perform the work.

RaiseRite crew members drilled two sets of 1" holes through the wood gymnasium floor to reach the concrete slab underneath every 5 feet apart. Crew members then drilled 5/8" holes through the concrete. A total of 520 lbs. of high-density 401 foam was injected through the holes where it started to expand and gradually raised the floor back to its original height. Work was completed in less than 8 hours and was immediately ready. Floor refinishers then came in and repaired the 1" holes as part of their refinishing process. New bleachers were soon installed afterwards and the floor was ready for use at the start of the new school year.
