# Case Study

## I-94 Milwaukee Highway Stabilization

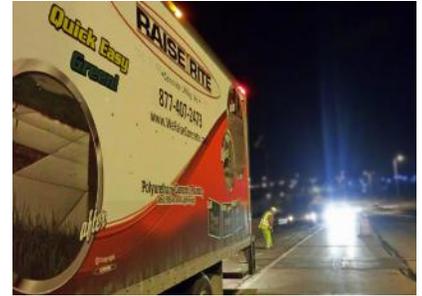
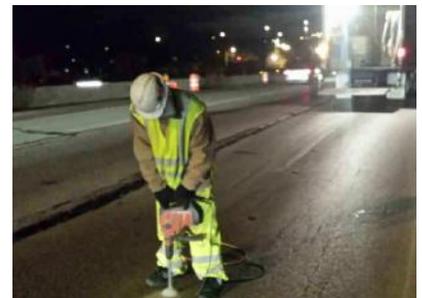
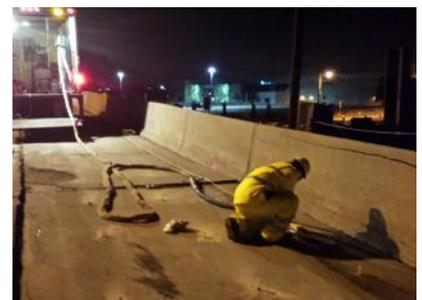
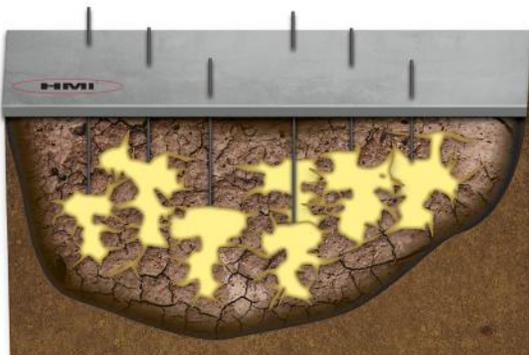
The two man RaiseRite crew arrived onsite the next day at 11:00 p.m. The contractor provided and set up traffic control. The voids were filled and the roadway was stabilized with 955 lbs. of HMI 501 polyurethane material. After the voids were successfully filled, the crew lifted the shoulders to line up with the roadway. The project was completed at 4:30 a.m., for a total project duration of 5 ½ hours on deck. Once the polyurethane cure time of 15 minutes was complete and traffic barriers removed, the roadway was opened for traffic. Even upon short notice, RaiseRite was able to arrive to onsite and successfully complete another highway stabilization project.
